## **Investigation & Mitigation of Corroding Unbonded Post-Tension Tendons**

### **ABSTRACT**

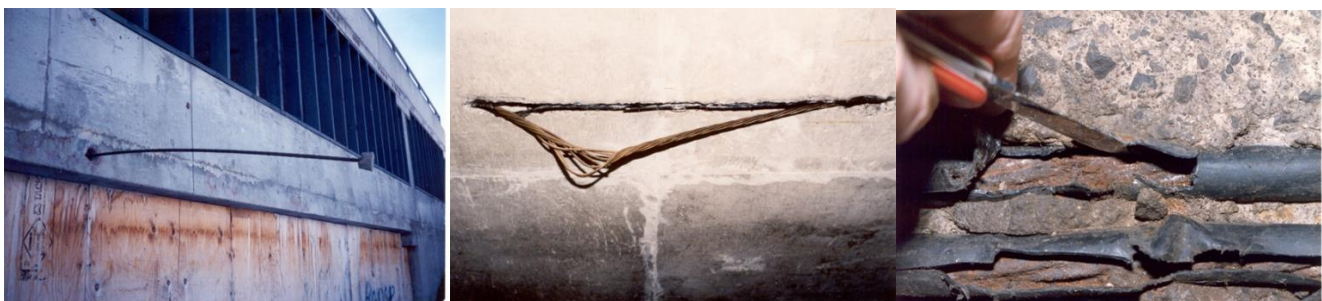
**Figure 1: Examples of post-tension tendon failure due to corrosion.**

Broken strands or entire tendons have been found during the investigation of many of the older types of unbonded post-tensioned structures. As the tendons are integral structural members, the loss of strands and tendons can significantly affect the structural capacity of the structure.
