GYPSUM ASSOCIATION

REPAIR OF GYPSUM BOARD JOINT RIDGING (GA-221-2000)

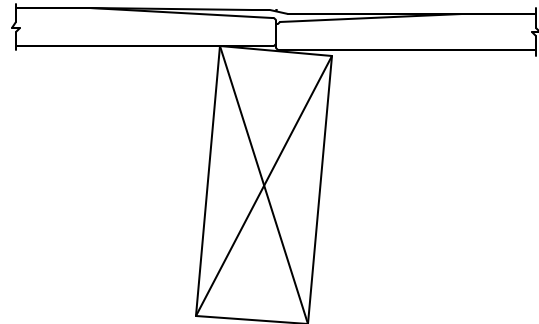
Typical Ridging at Taper-to-Butt Joint
